Arlington Housing Authority
Building Envelope Repairs, Window Replacement, Phase 1
Winslow Towers 667-3, Elderly Housing
Schematic Report and Recommendations

Re: Winslow Towers Condition Assessment - DRAFT
WJE No. 2017.6855

Wiss, Janney, Elstner Associates, Inc. (WJE) completed a facade condition assessment and performed diagnostic water penetration testing at the Arlington Housing Authority (AHA) property Winslow Towers located at 4 Winslow Street in Arlington, Massachusetts. This letter is intended to serve as a summary of our observations and provide recommendations for short and long-term repairs.

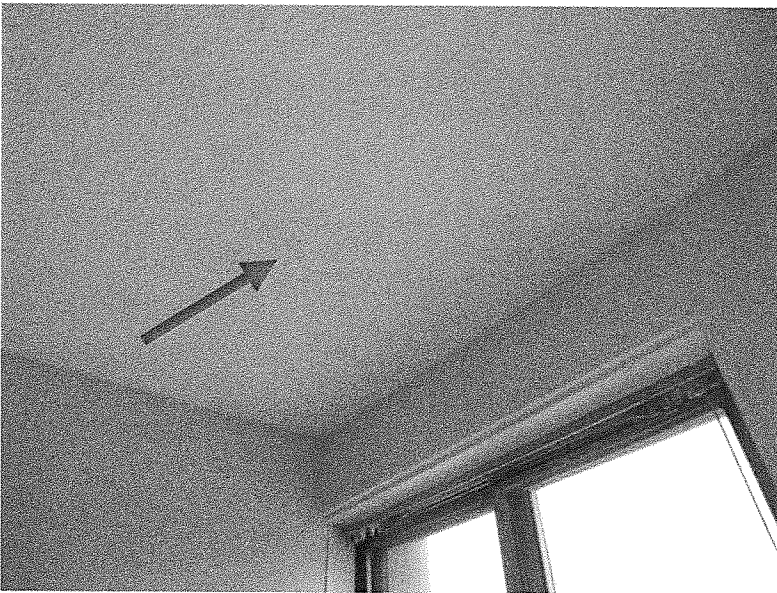
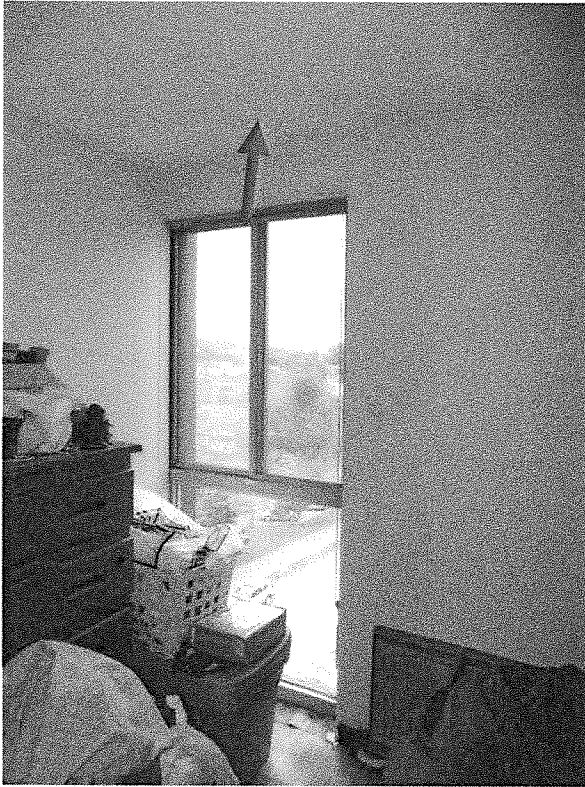
Figure 58. Water droplets on ceiling in bedroom of unit 902

Figure 59. Water observed on ceiling in bedroom of unit 902

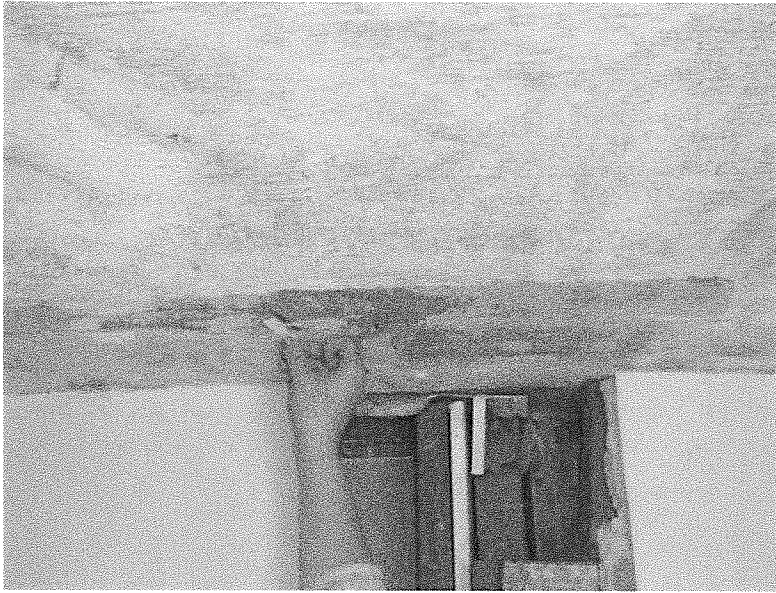
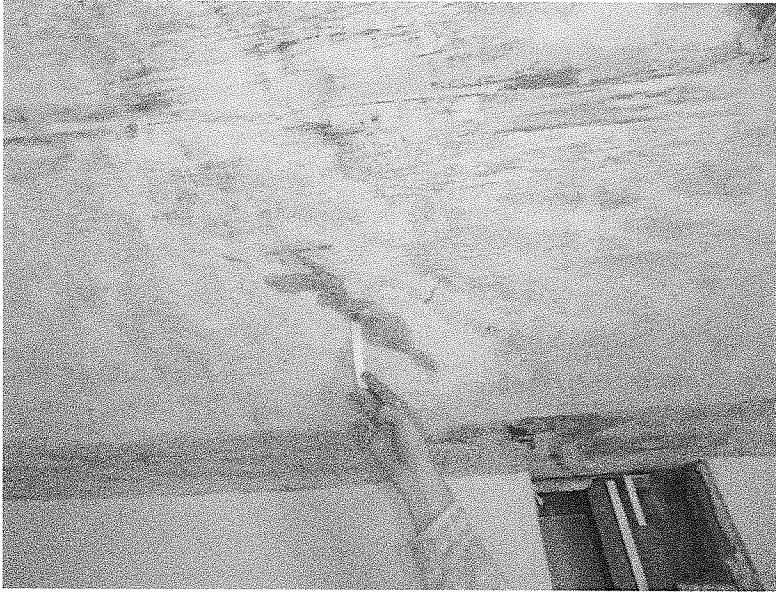
Testing was subsequently performed at the vertical sealant joint along the interface between the concrete wall and the masonry infill wall at the building corner. The third test started at this vertical corner sealant joint, starting at the soffit of the twelfth-floor concrete perimeter beam (immediately above the eleventh-floor window level). During this test it was reported that there was water infiltration at Unit 902, two floors below. Testing was temporarily stopped. Water infiltration was observed at the ceiling adjacent to the bedroom window in Unit 902 (Figure 58 and Figure 59). Testing restarted at the vertical sealant joint. Testing was performed by spraying water up the vertical sealant joint, moving the nozzle at a speed of 1 LF/minute (Figure 60). After 15 minutes, water was observed at the ceiling, at a concrete crack approximately two feet from the exterior wall (Figure 61). As the test continued, the water infiltration moved further into the interior along the concrete crack (Figure 62). The test was concluded after approximately 30 minutes. Water continued to enter at the ceiling even after the water was shut off.

Figure 61. Water leakage on ceiling in the living room of unit 1102 following spraying of exterior vertical sealant joint (indicator paper turns pink upon water contact)

Figure 62. Greater water leakage on ceiling in the living room of unit 1102 following spraying of exterior vertical sealant joint (indicator paper turns pink upon water contact)

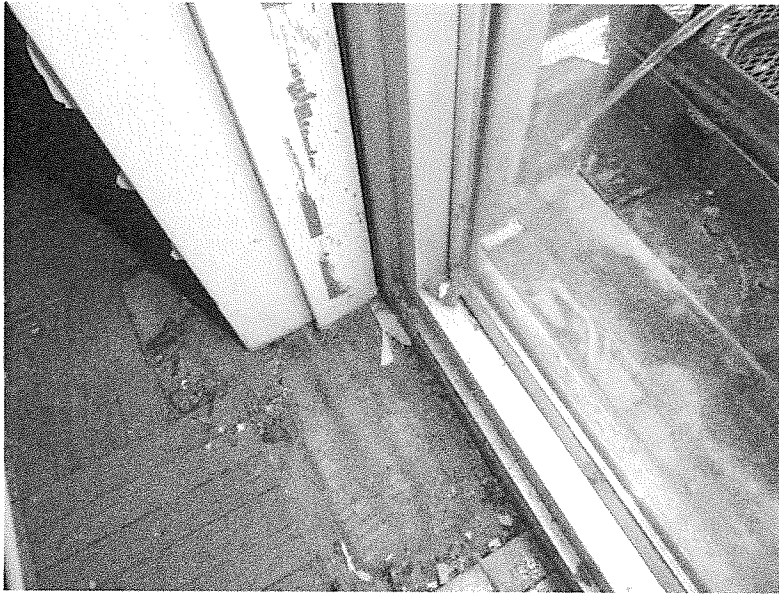
Subsequent testing at the fourth location was at the facade corner at the living room. Initial testing at this location focused on the floor line and the window sill. Testing was performed by spraying water along the floor line at the interface of the concrete perimeter beam and brick infill above, moving the nozzle at a speed of 1 LF/minute towards the window (Figure 63). Testing ended at the window sill flashing when water was observed at the interior at the floor (Figure 64). Parquet flooring was removed to better observe the water infiltration. Water continued to enter below the living room window even after the water was shut off. Voids in the sealant at the window sill were noted during the testing (Figure 65 and Figure 66). Additional testing (Test No. 5 in Table 1) at the concrete perimeter beam flashing (below the beam) in the same area did not result in any additional water infiltration (Figure 67).

Figure 64. Water infiltration observed at window in living room of unit 1102 (indicator paper turns pink upon water contact)

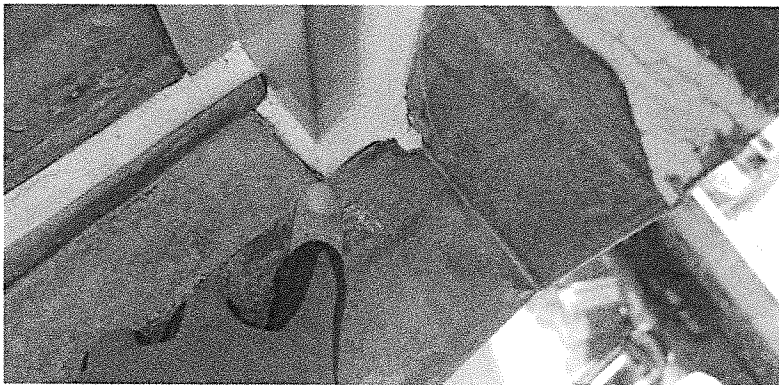
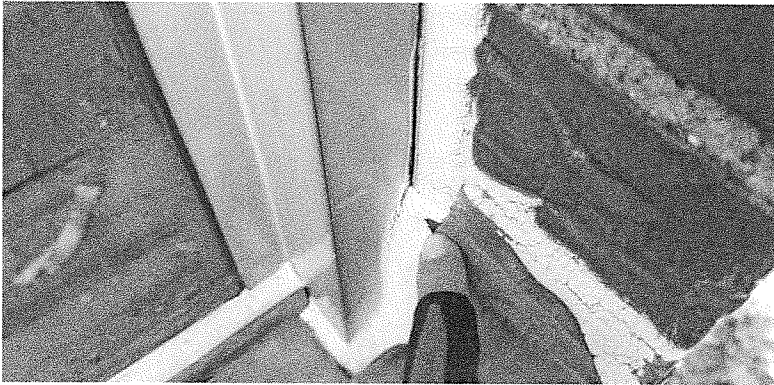
Figure 65. Void in sealant at window sill of living room window of unit 1102

Figure 66. Void in sealant at window sill of living room window of unit 1102
